***Final Report for the Second Train
Warning Sign Demonstration Project on
the Los Angeles Metro Blue Line***

January 10, 2002

FTA-CA-26-7017-01

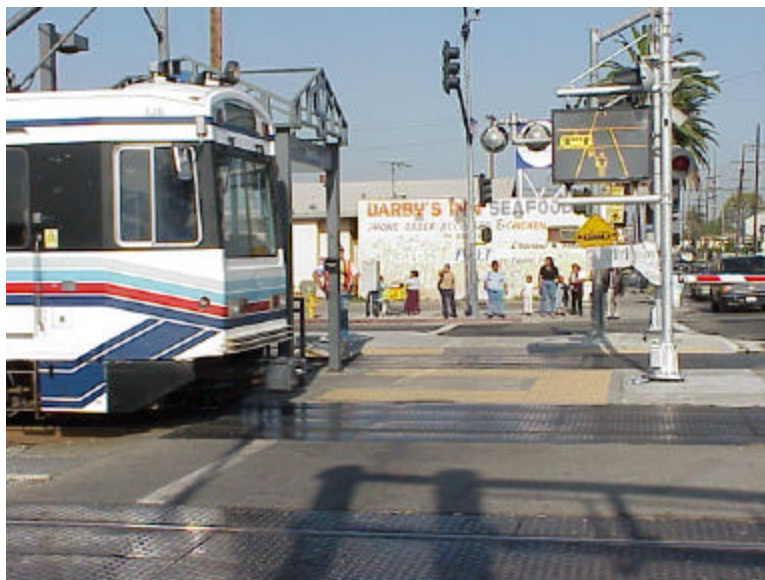
**Figure 1
VIEW OF INSTALLED
SECOND TRAIN WARNING
SIGN LOOKING WEST**

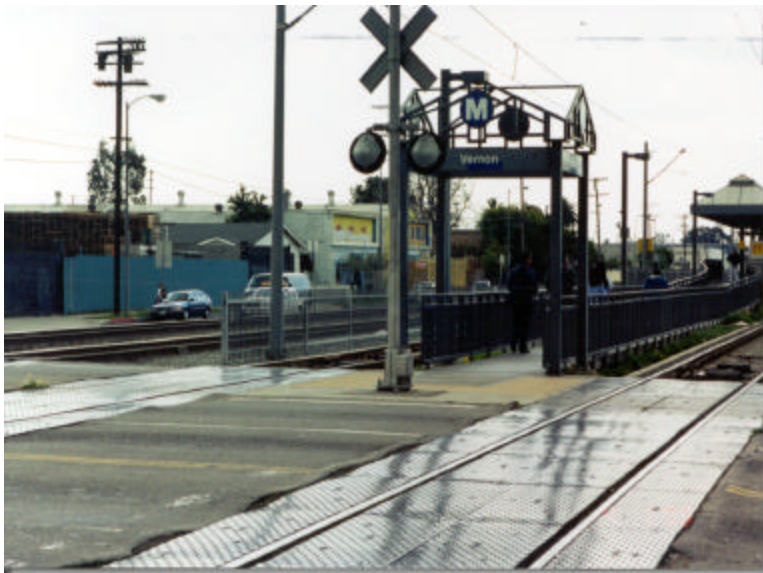
**Figure 2
VIEW OF VERNON AVENUE
HIGHWAY-RAILROAD
INTERSECTION**

The demonstration project was conducted at the Vernon Avenue HRI in the City of Los Angeles, one of the MBL's most hazardous HRIs. The demonstration project was carried out on the south side sidewalk at the Vernon Avenue crossing of the MBL and adjacent freight railroad tracks owned and maintained by the UPRR. The sidewalk crosses two LRT tracks, one normally NB and one normally SB, and two UPRR freight tracks. The entrance to the Vernon Avenue station is located between the normally NB and normally SB LRT tracks.

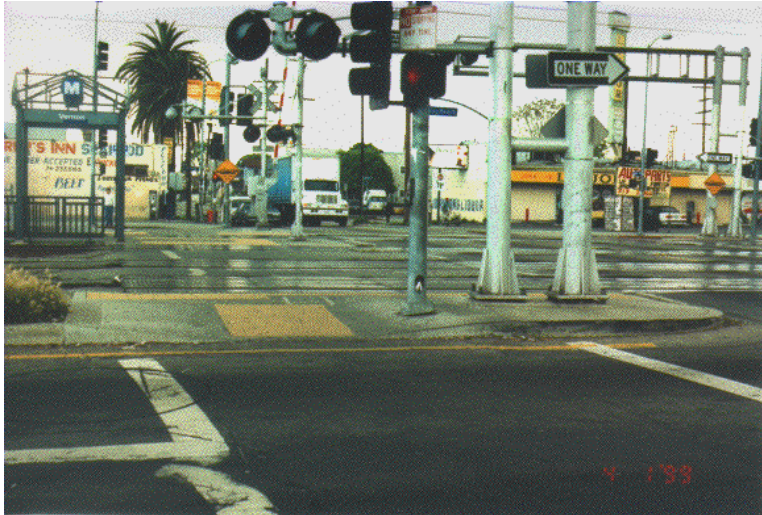
Figure 3
VIEW OF VERNON AVENUE
HIGHWAY-RAILROAD
INTERSECTION

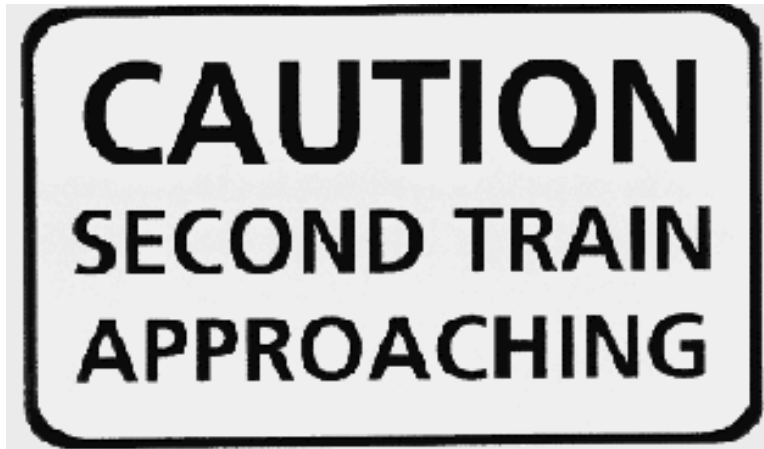
Figure 4
TEXT SIGN 1

The first text sign consisted of a static message, CAUTION SECOND TRAIN APPROACHING, activated when two trains were at or in the vicinity of the Vernon Avenue HRI. The sign is depicted in Figure 4 on the next page.

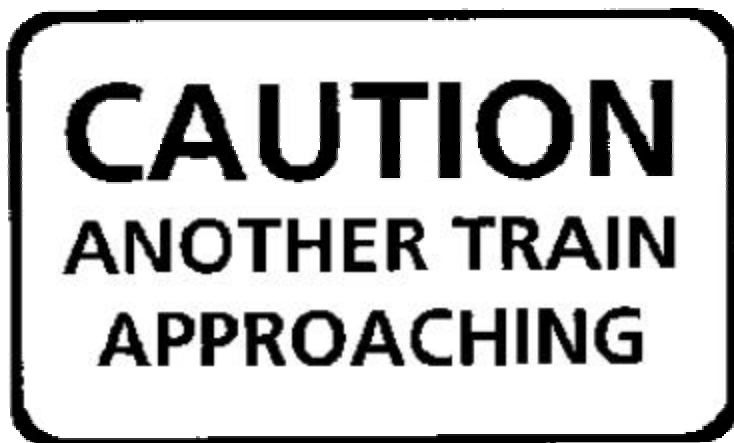
Figure 5
TEXT SIGN 2

The second text sign consisted of a static message, CAUTION ANOTHER TRAIN APPROACHING, activated when two trains were at or in the vicinity of the Vernon Avenue HRI. This wording was selected for further testing because of the possibility of up to four trains at the same time at the Vernon Avenue HRI. The second text sign is shown in Figure 5.

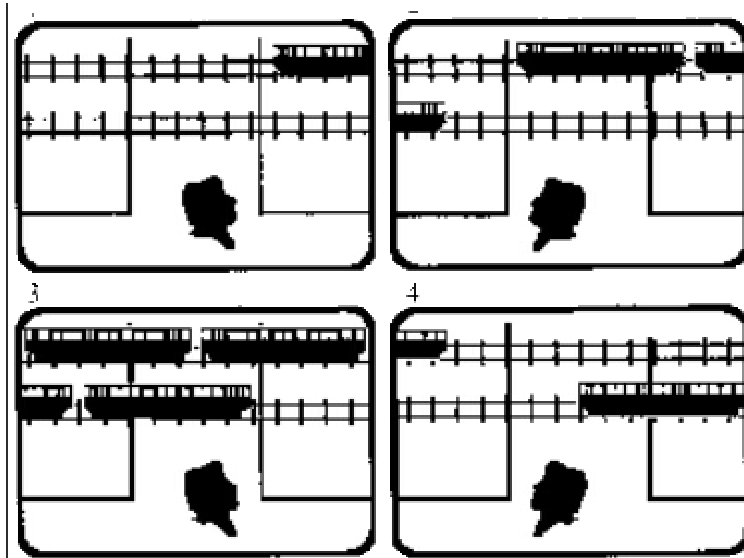
Figure 6
GRAPHIC SIGN 1

The first graphic sign selected for further consideration by the expert panel consisted of an animation, incorporating motion by both two LRT vehicles and a pedestrian turning head. The LRT vehicles, one from the right and then one from the left, were displayed in continuous motion after the sign was activated. The pedestrian turning head was also displayed in continuous motion, looking to the right and then to the left.

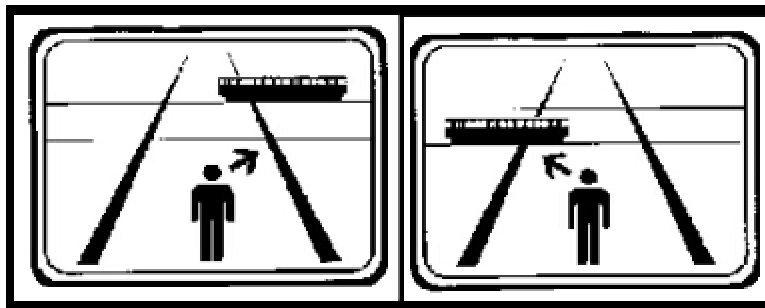
Figure 7
GRAPHIC SIGN 2

This sign showed a two-part display, with the sign alternating between the two displays when activated by the presence of two trains at the same time. The first display showed a LRT vehicle on the top track and located to the right hand side of the display, with an arrow pointing from a pedestrian standing in front of the two tracks towards the LRT vehicle. The second display showed a LRT vehicle on the lower track and located to the left hand side of the display, with an arrow pointing from a pedestrian standing in front of the two tracks towards the LRT vehicle.

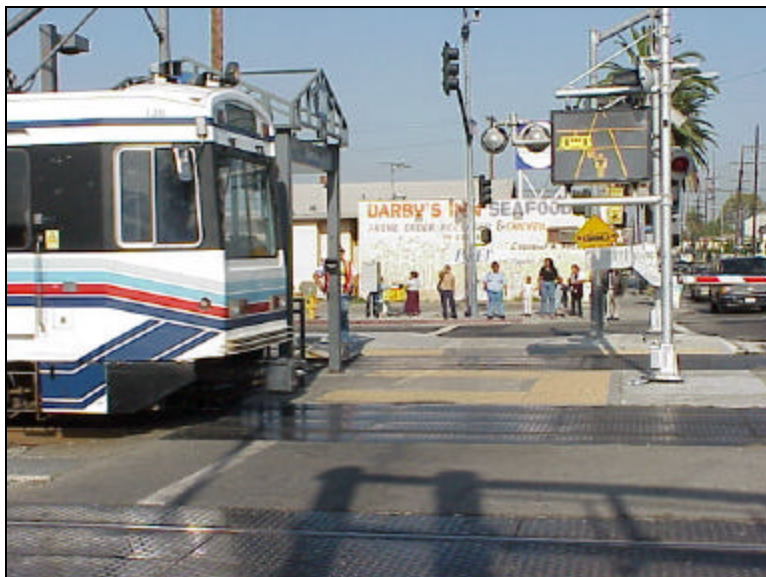
Figure 8
VIEW OF INSTALLED
SECOND TRAIN WARNING
SIGN AND NORTHBOUND
LRT TRAIN

Installation of the warning sign was done under LACMTA Contract C0360, Metro Blue Line Grade Crossing Improvements. The warning sign was installed and made operational in June 2000.

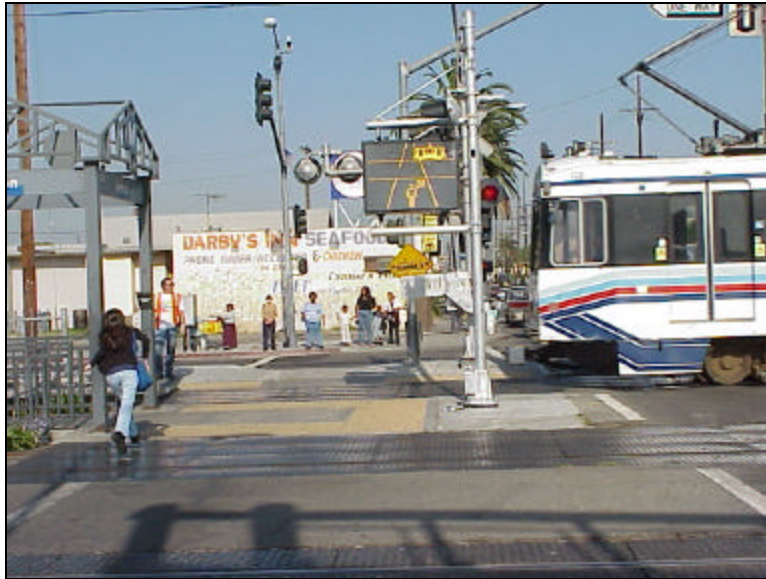
**Figure 9
VIEW OF INSTALLED
SECOND TRAIN WARNING
SIGN AND SOUTHBOUND
LRT TRAIN**

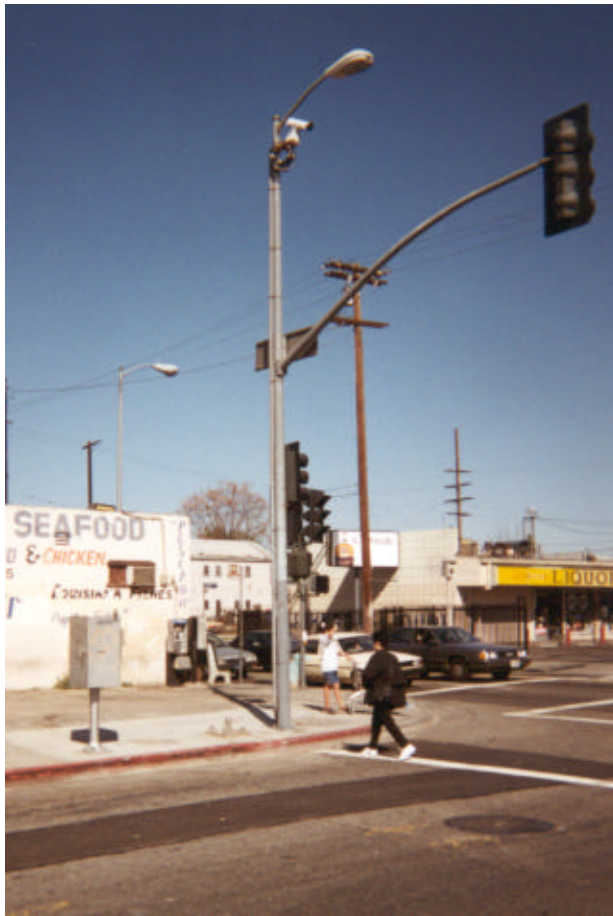
A video camera was installed in the southwest corner of Vernon Avenue and Long Beach Avenue West. The existing traffic signal pole at this location was replaced with a tall traffic signal pole that provides for mounting of the camera unit at the top of the pole. This location has provided a clear view of the track area for video observation and data collection.

Figure 10
VIDEO CAMERA INSTALLED AT
VERNON AVENUE

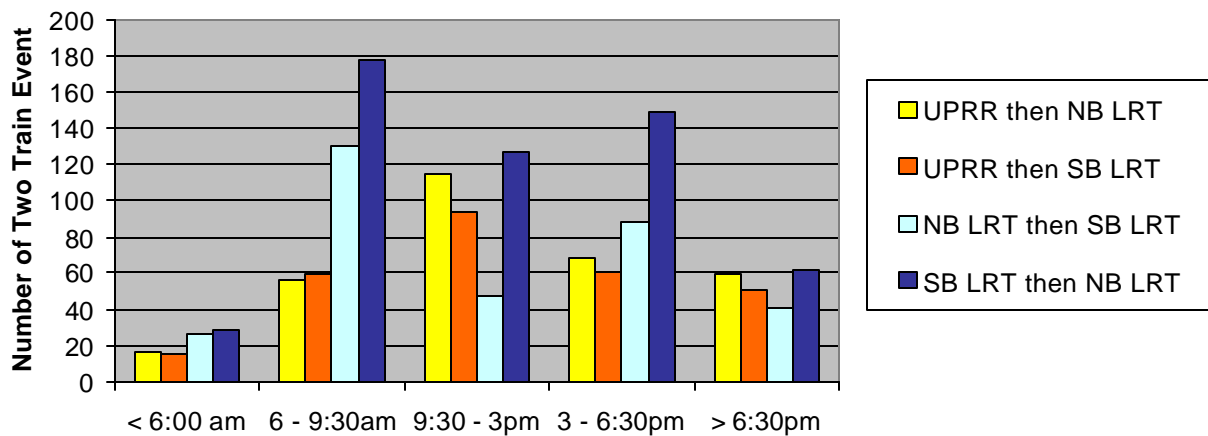
Table 4 shows the number of two train events recorded during different times of day for different combinations or variations of two trains at the same time. As already noted, a total of 1,470 two train events were observed in the before data collection time period. Figure 11 shows the same data presented in Table 4 but shows the data as a bar chart for each time period. Note that the incidence of two trains at the same time is highest during the peak periods, and somewhat higher during the AM peak period than during the PM peak period.

Figure 11
TWO TRAIN EVENTS BY TIME OF DAY
BEFORE INSTALLATION

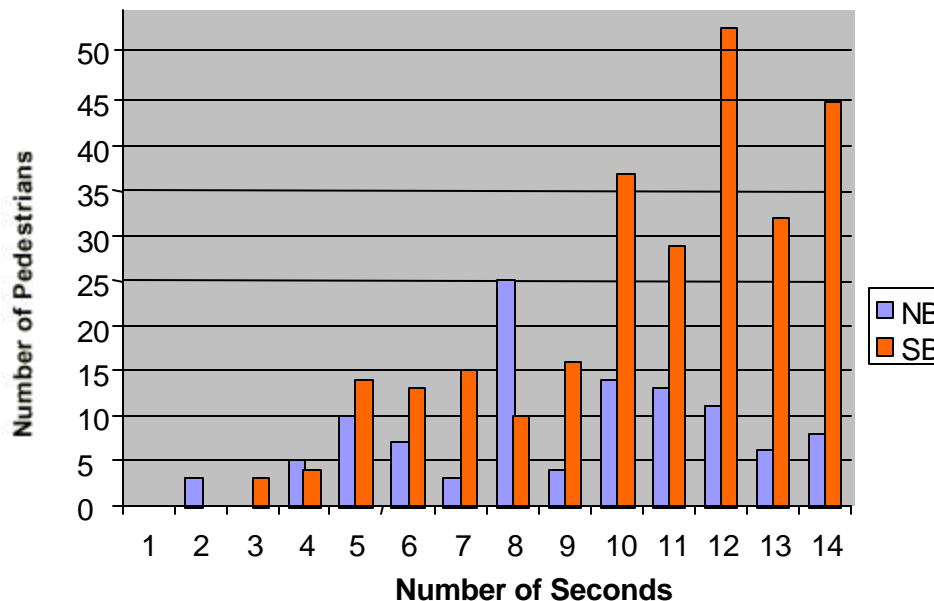
A total of 380 pedestrians were observed crossing the LRT tracks at less than 15 seconds in front of an approaching LRT train. Table 5 summarizes the breakdown of pedestrian crossing times, less than 15 seconds, for each train direction. Figure 12 shows the same data in a graphic format.

The findings demonstrate that pedestrians, in some cases, cross the tracks without any attention to the second train. On 59 occasions, pedestrians were observed crossing the tracks at six seconds or less before an LRT train entered the crossing. On 15 occasions, pedestrians crossed the tracks at four seconds or less in front of an approaching train. On the other hand, a total of 248 of the pedestrians

There is a noticeable spike at eight seconds for NB risky crossings. One group of seven pedestrians crossing at the same time is included in this category.

About 71 percent of the risky pedestrian crossings were observed for the normally southbound track, track 2. It should be noted that the approach times on this approach to the crossing are in excess of 40 seconds as the result of a slow order, meaning that pedestrians have extended warning time to observe the approaching southbound trains before entering the track area.

Figure 12
BREAKDOWN OF PEDESTRIAN RISKY CROSSING TIMES
BEFORE INSTALLATION

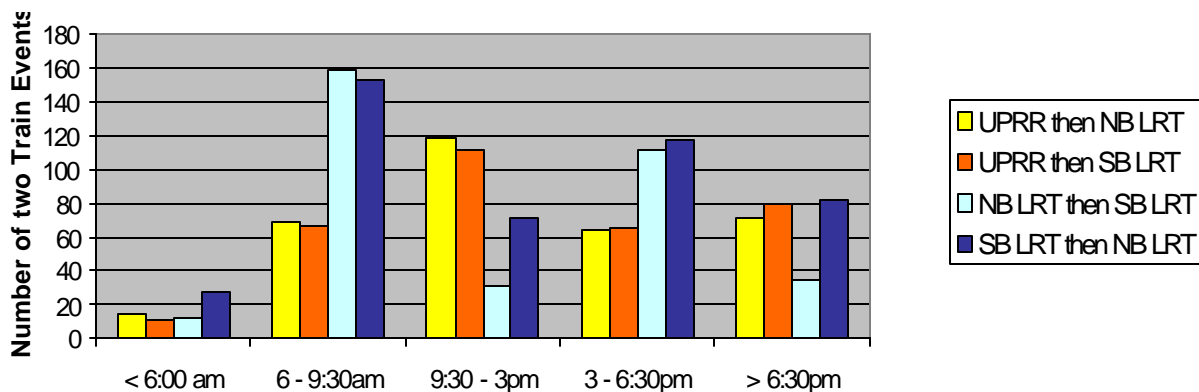
Figure 13
TWO TRAIN EVENTS BY TYPE AND TIME OF DAY
AFTER INSTALLATION

Table 7 shows the number of two train events recorded during different times of day for different combinations or variations of two trains at the same time. As already noted, a total of 1,470 two train events were observed in the after data collection time period. The same data is depicted graphically in Figure 13. The breakdown is remarkably the same as recorded for the before installation time period, with a lower number of two train events with a NB train in the station and a somewhat higher number of two train events involving UPRR freight trains during the mid-day hours.

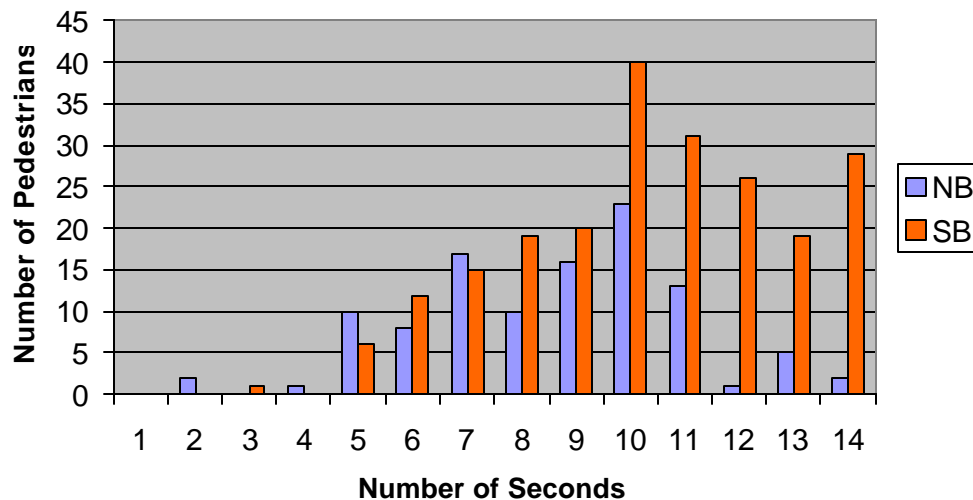
A total of 326 pedestrians were observed crossing the LRT tracks at less than 15 seconds in front of an approaching LRT train after the warning sign was installed. This was a reduction of 14 percent in the total number of risky pedestrian crossings. Table 8 summarizes the breakdown of pedestrian crossing times, less than 15 seconds, for each train direction. Figure 14 shows the same data graphically.

Figure 14
BREAKDOWN OF PEDESTRIAN RISKY CROSSING TIMES
AFTER INSTALLATION

The number of pedestrians crossing the tracks at six seconds or less before an LRT train entered the crossing was reduced from 59 to 40, a reduction of about 32 percent. The number of pedestrians crossing the tracks at four seconds or less in front of an approaching train was reduced from 15 to four, a substantial 73 percent decline in this type of especially risky behavior. These reductions are the most significant findings from the demonstration project.

The number of pedestrians crossing between 10 seconds and 14 seconds in front of an approaching LRT train dropped from 248 to 189, a 24 percent change from the before installation data collection period.

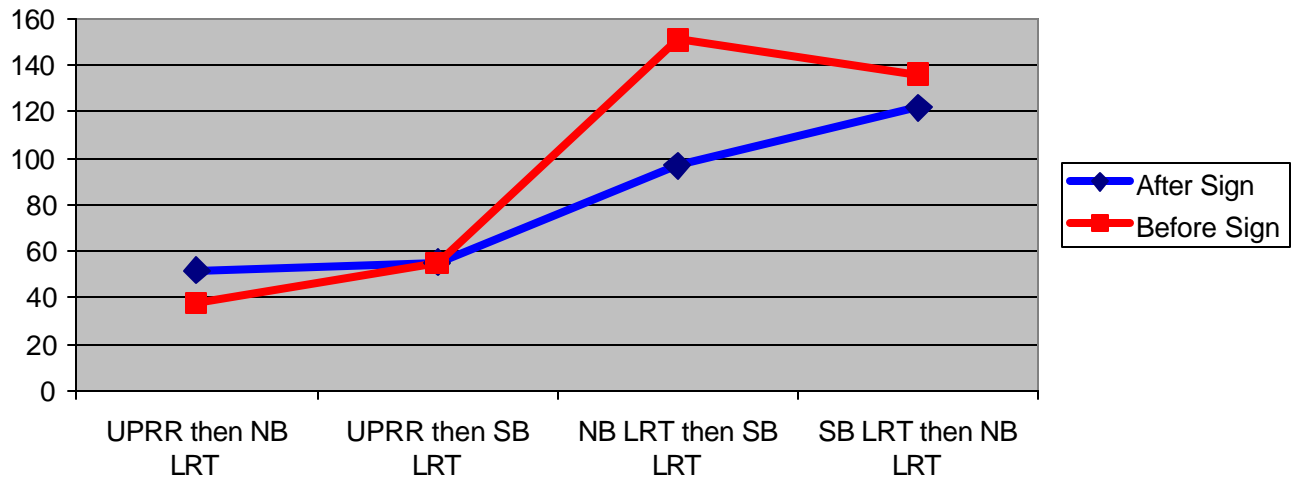
Figure 15, on the following page, provides a comparison of the number of pedestrian risky crossings, made at less than 15 seconds in front of an approaching train, for the before installation and after installation time periods by the type of two train event. There is a noticeable reduction in the number of pedestrian risky crossings for instances where there are two LRT trains at the same time.

Figure 15
COMPARISON OF PEDESTRIAN RISKY CROSSINGS
BY TYPE OF TWO TRAIN EVENT

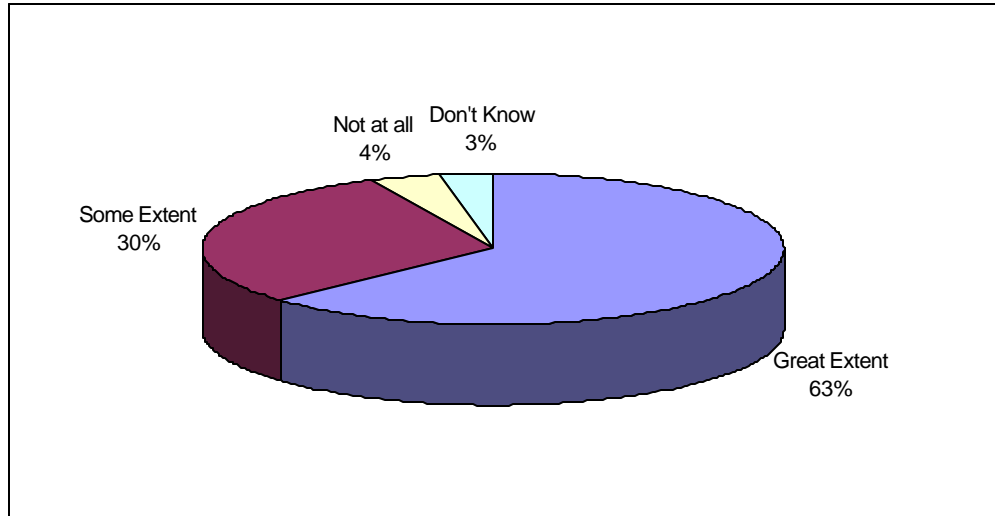
Figure 16
EXTENT TO WHICH THE WARNING SIGN IMPROVES SAFETY
AT THE VERNON AVENUE CROSSING
BASED ON PEDESTRIAN SURVEY RESPONSES
